Photo Log

Stony Ford Road – Ford Farms

by Andreescu, Stephanie

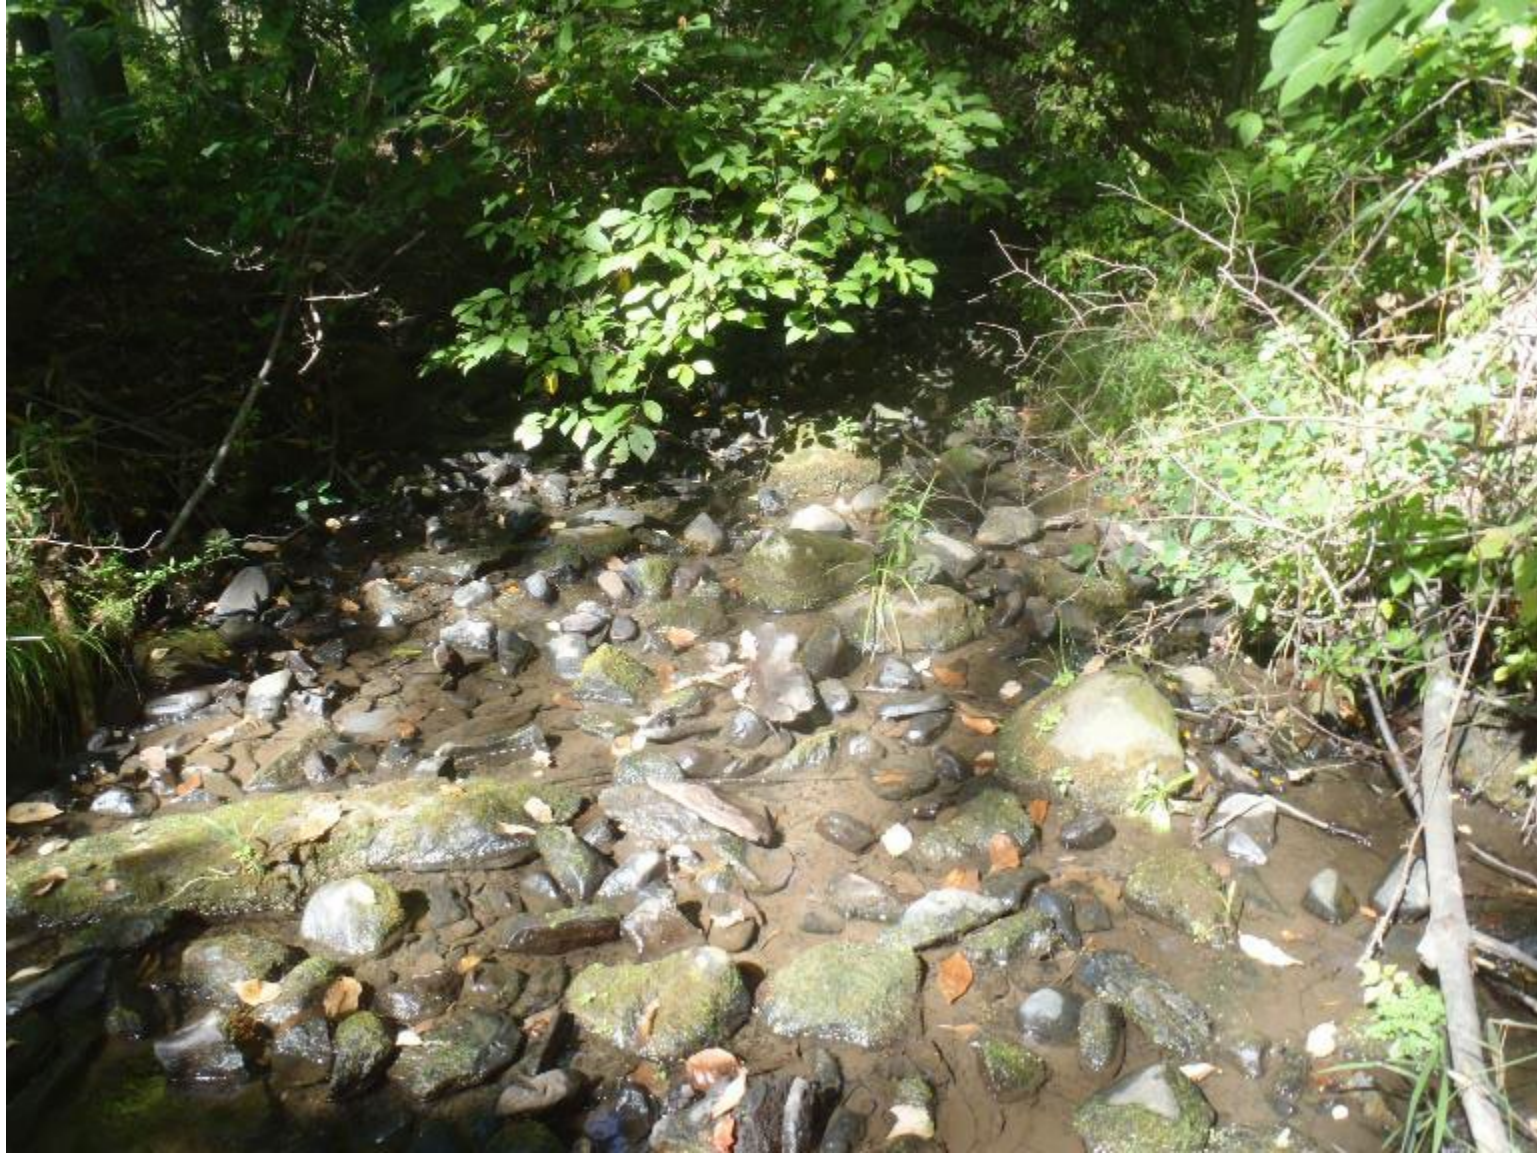
P9220001 – Upstream of Disturbance, Looking Upstream

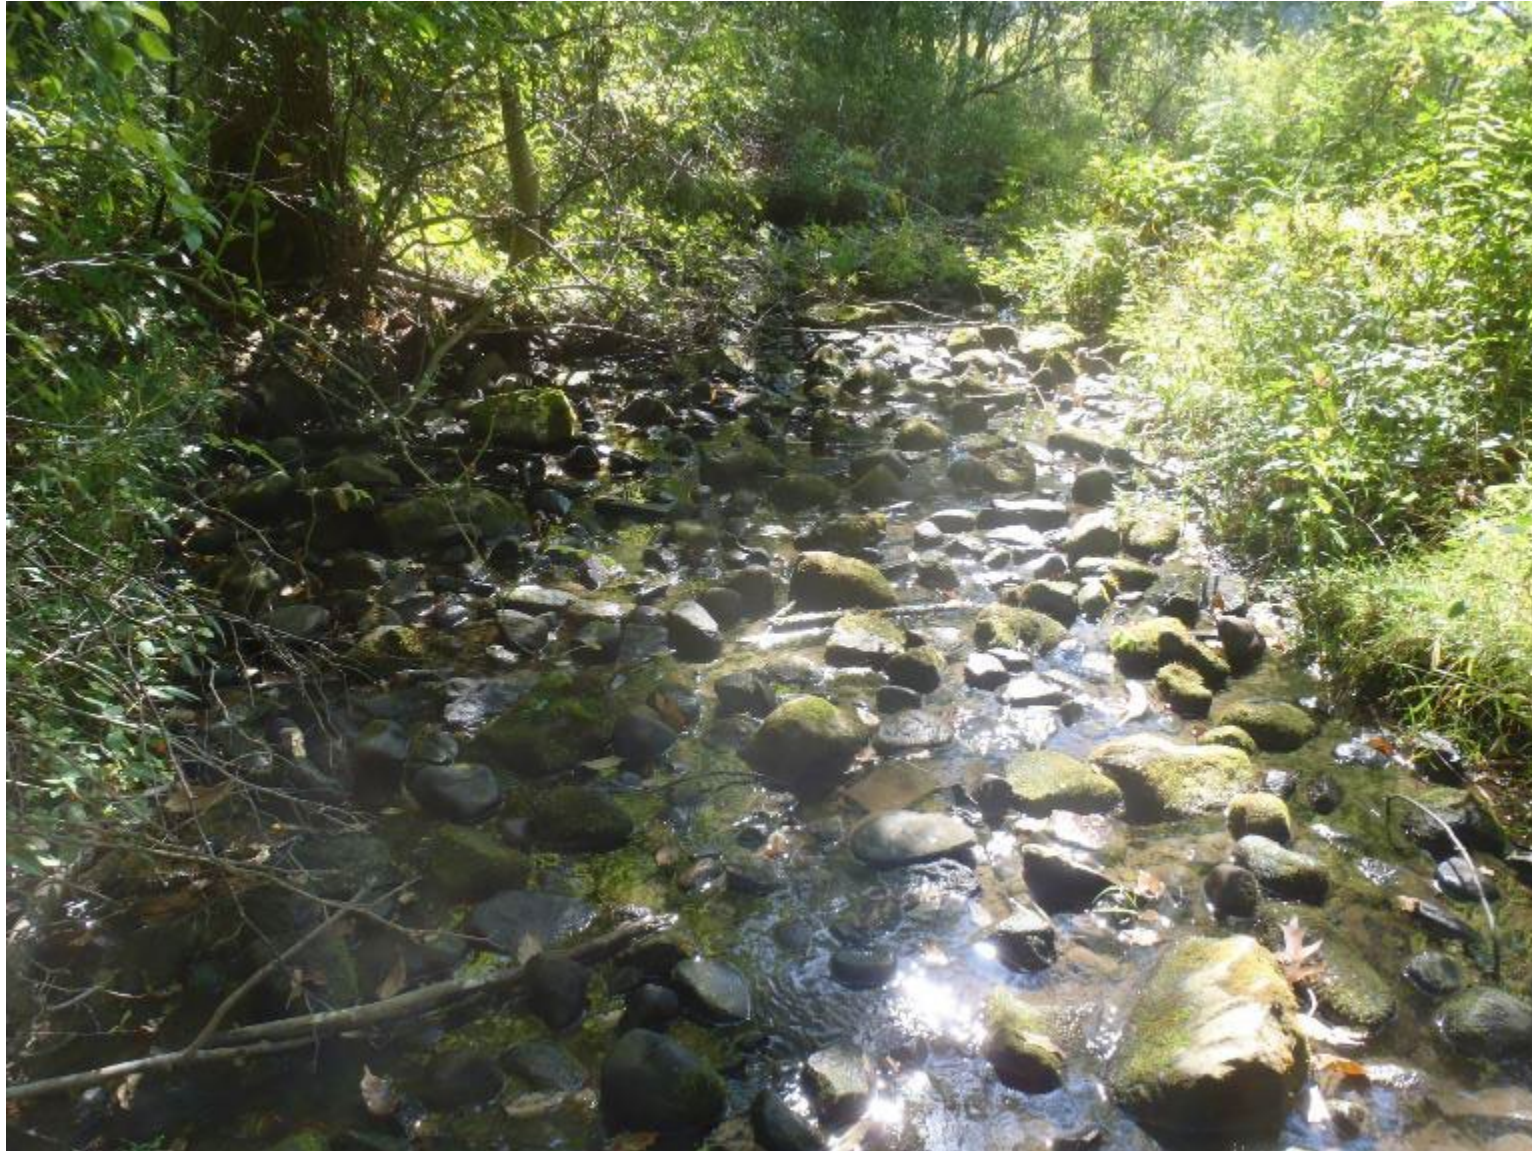
P9220002 – Upstream of Disturbance, Looking Downstream

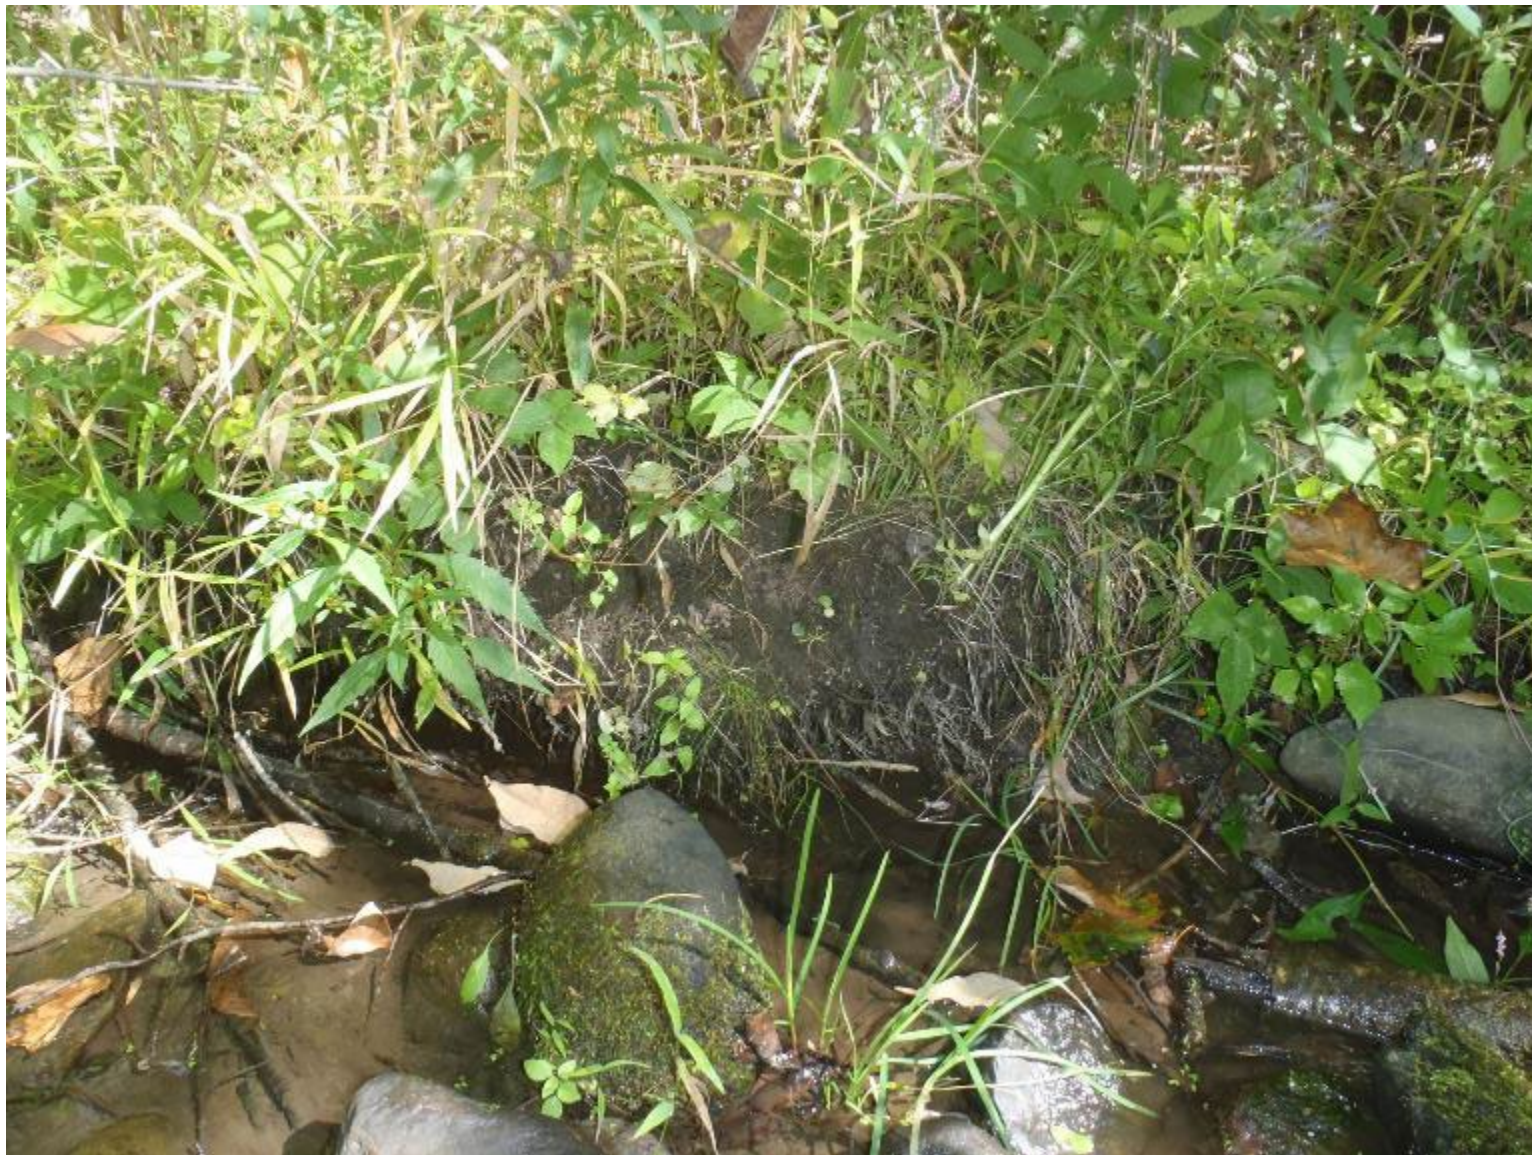
P9220003 – Upstream of Disturbance, Looking at Bank

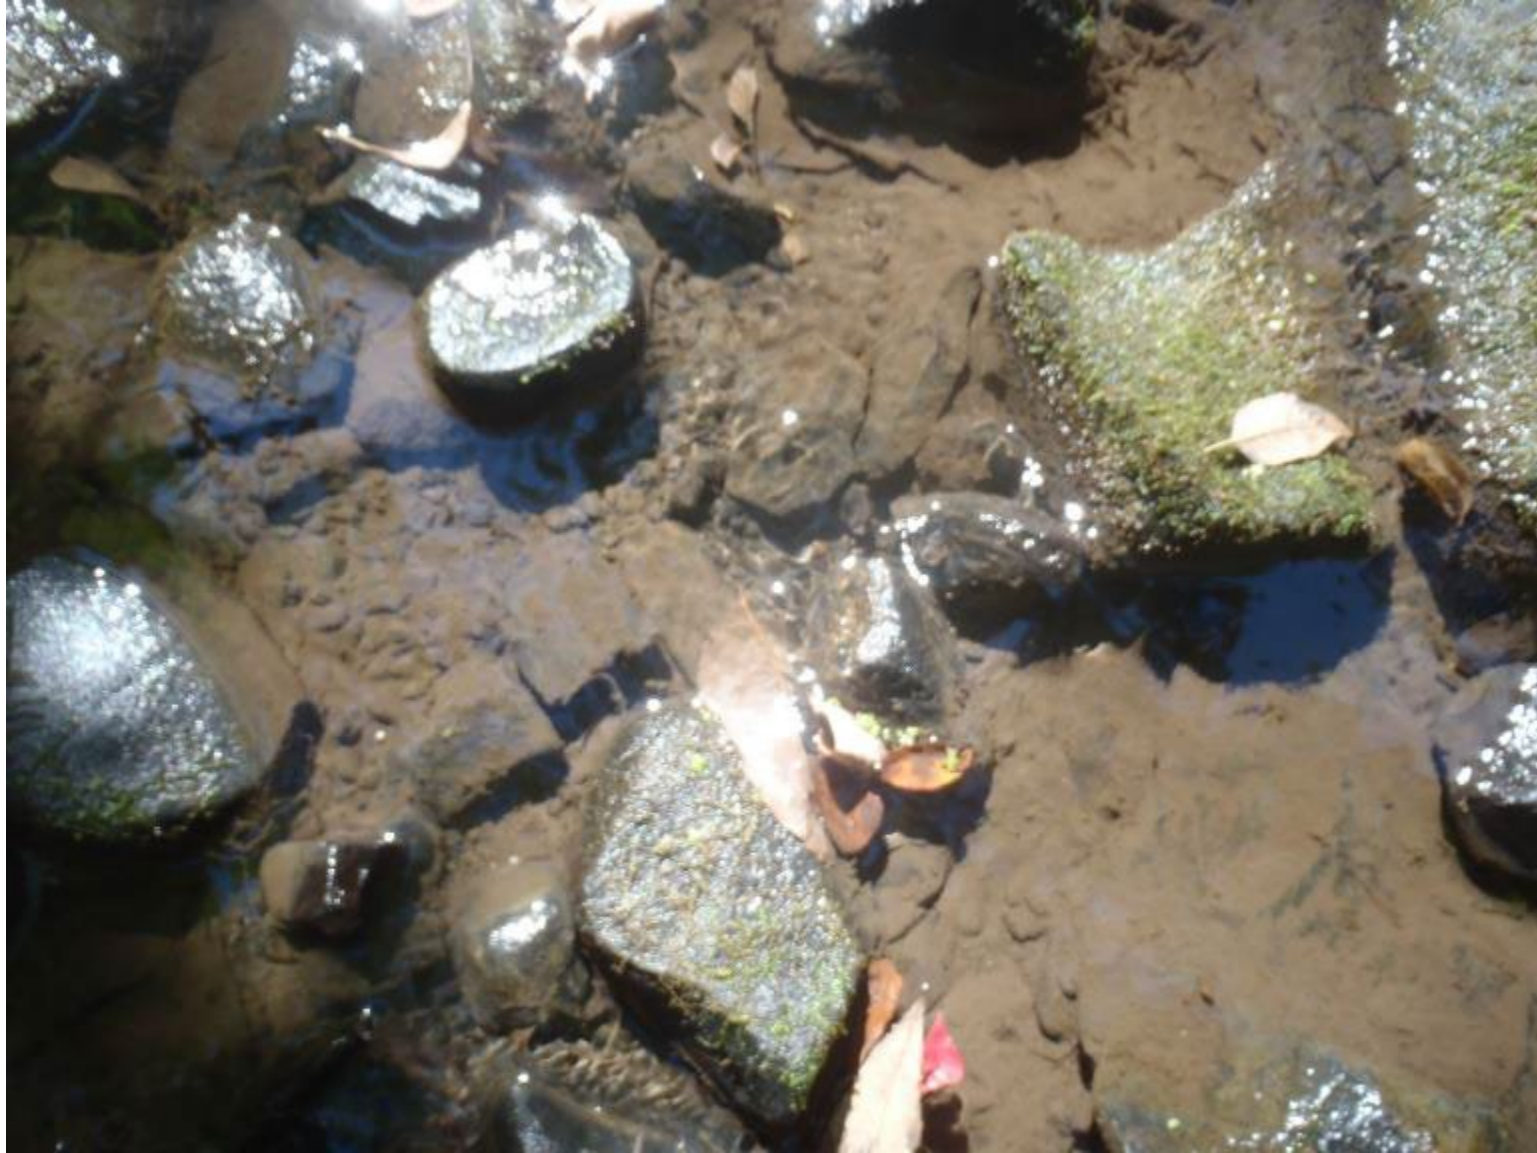
P9220004 – Upstream of Disturbance, Sediment

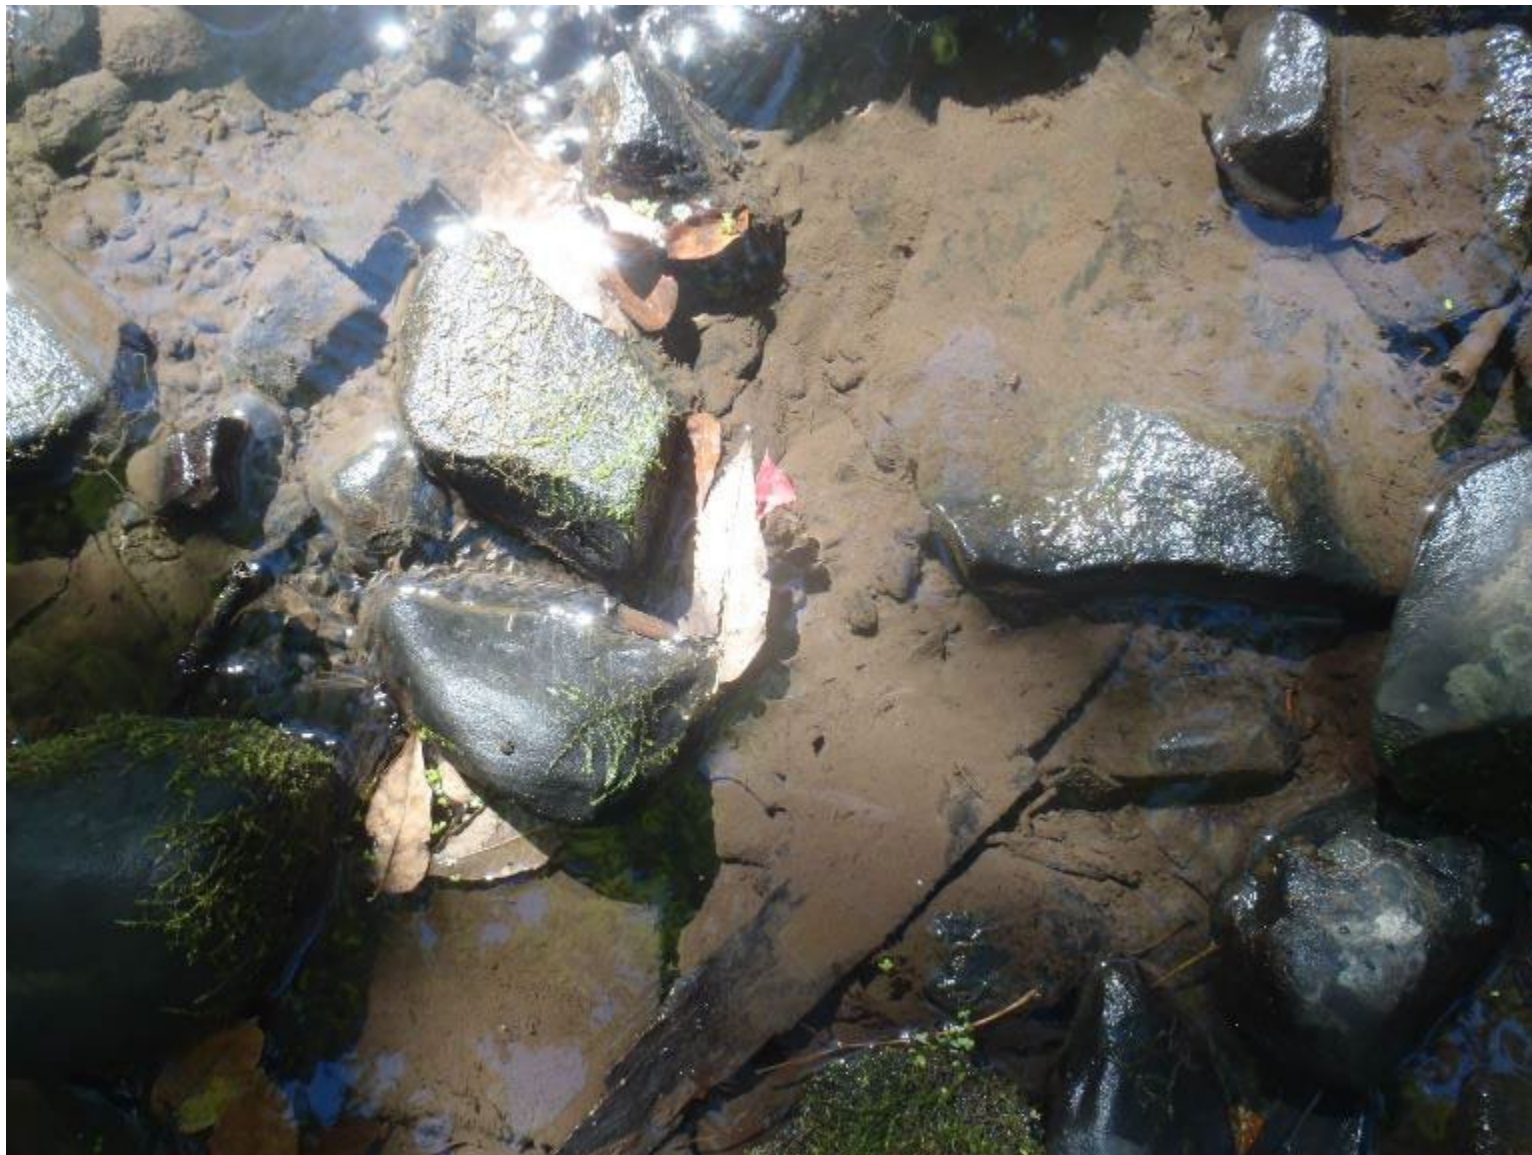
P9220005 – Upstream of Disturbance, Sediment

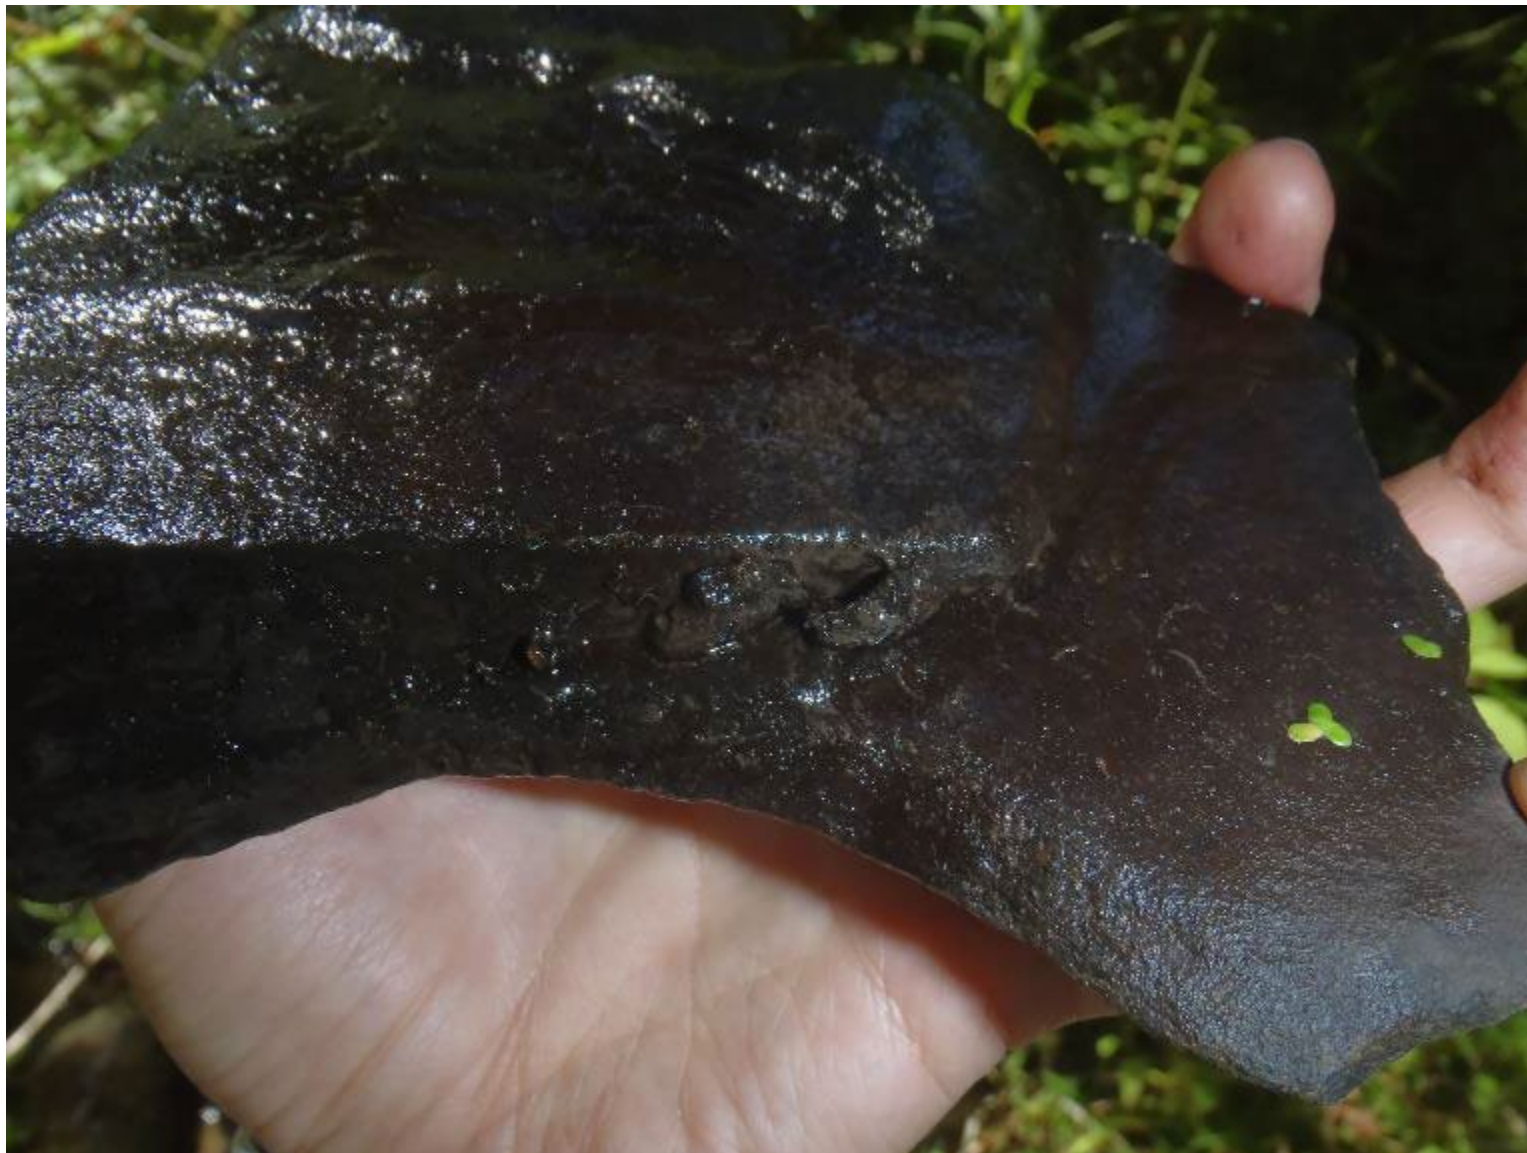
P9220006 – Upstream of Disturbance, 2 Caddisfly cases attached to bottom of rock

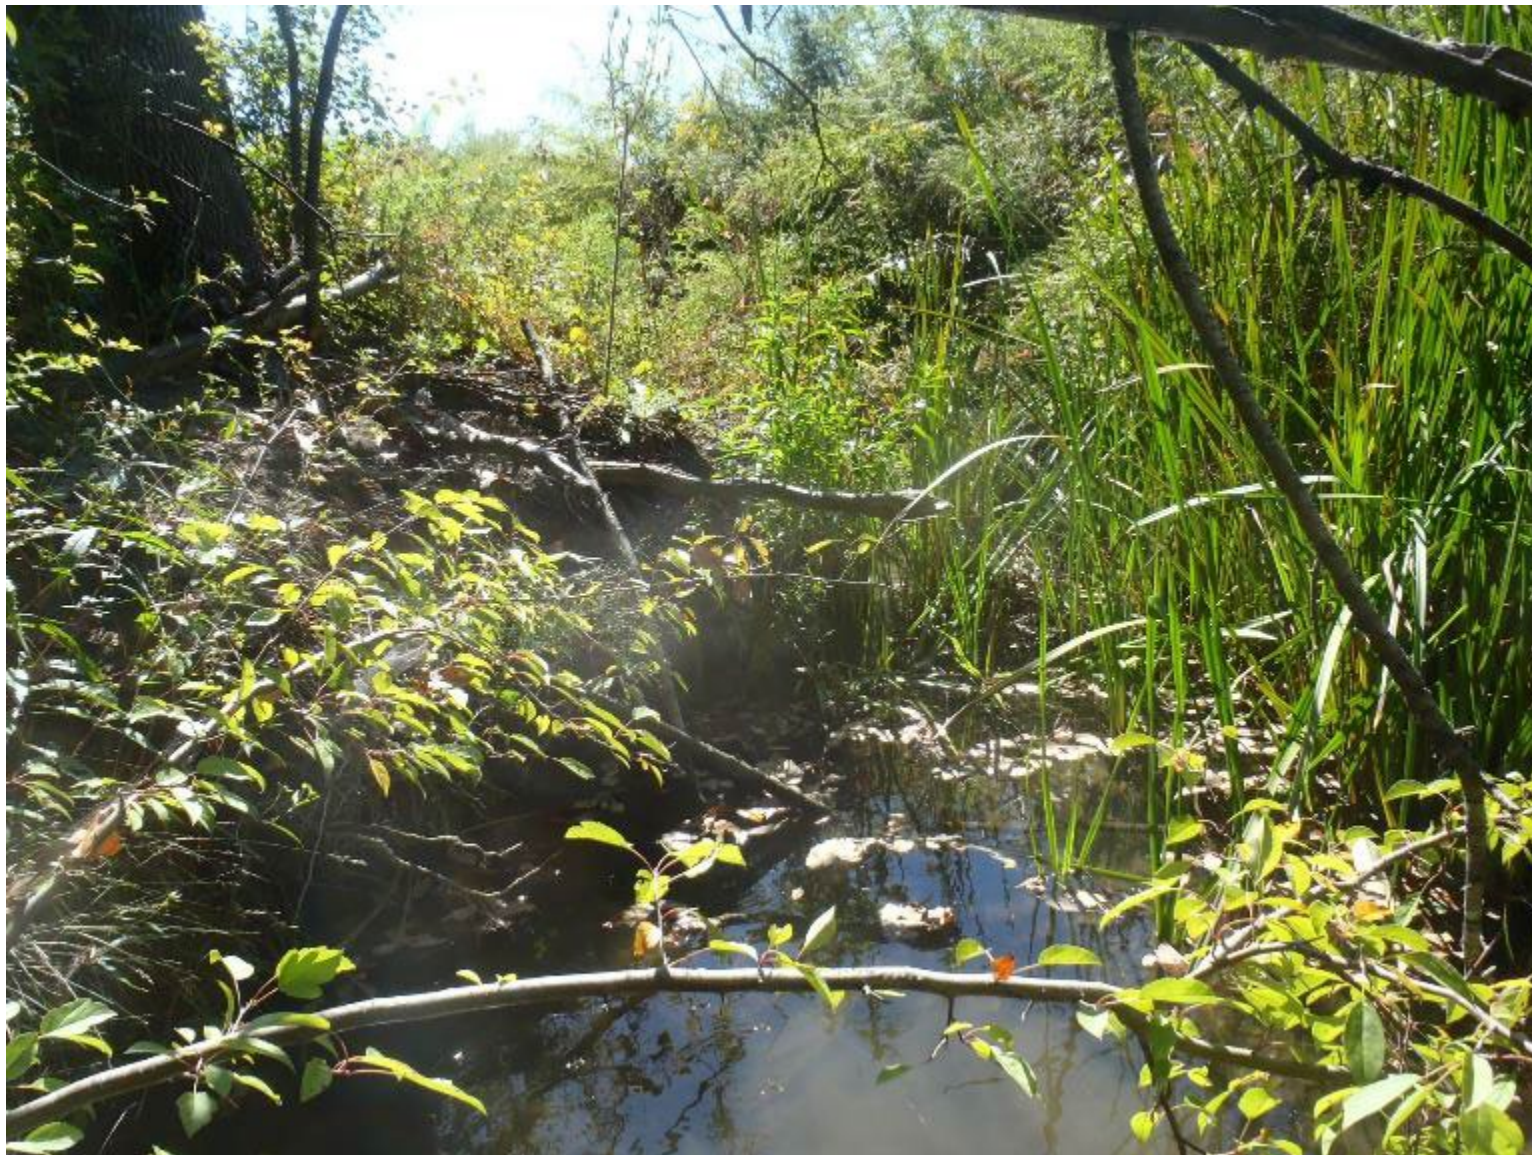
P9220007 – Upstream of Disturbance, Looking at Fill

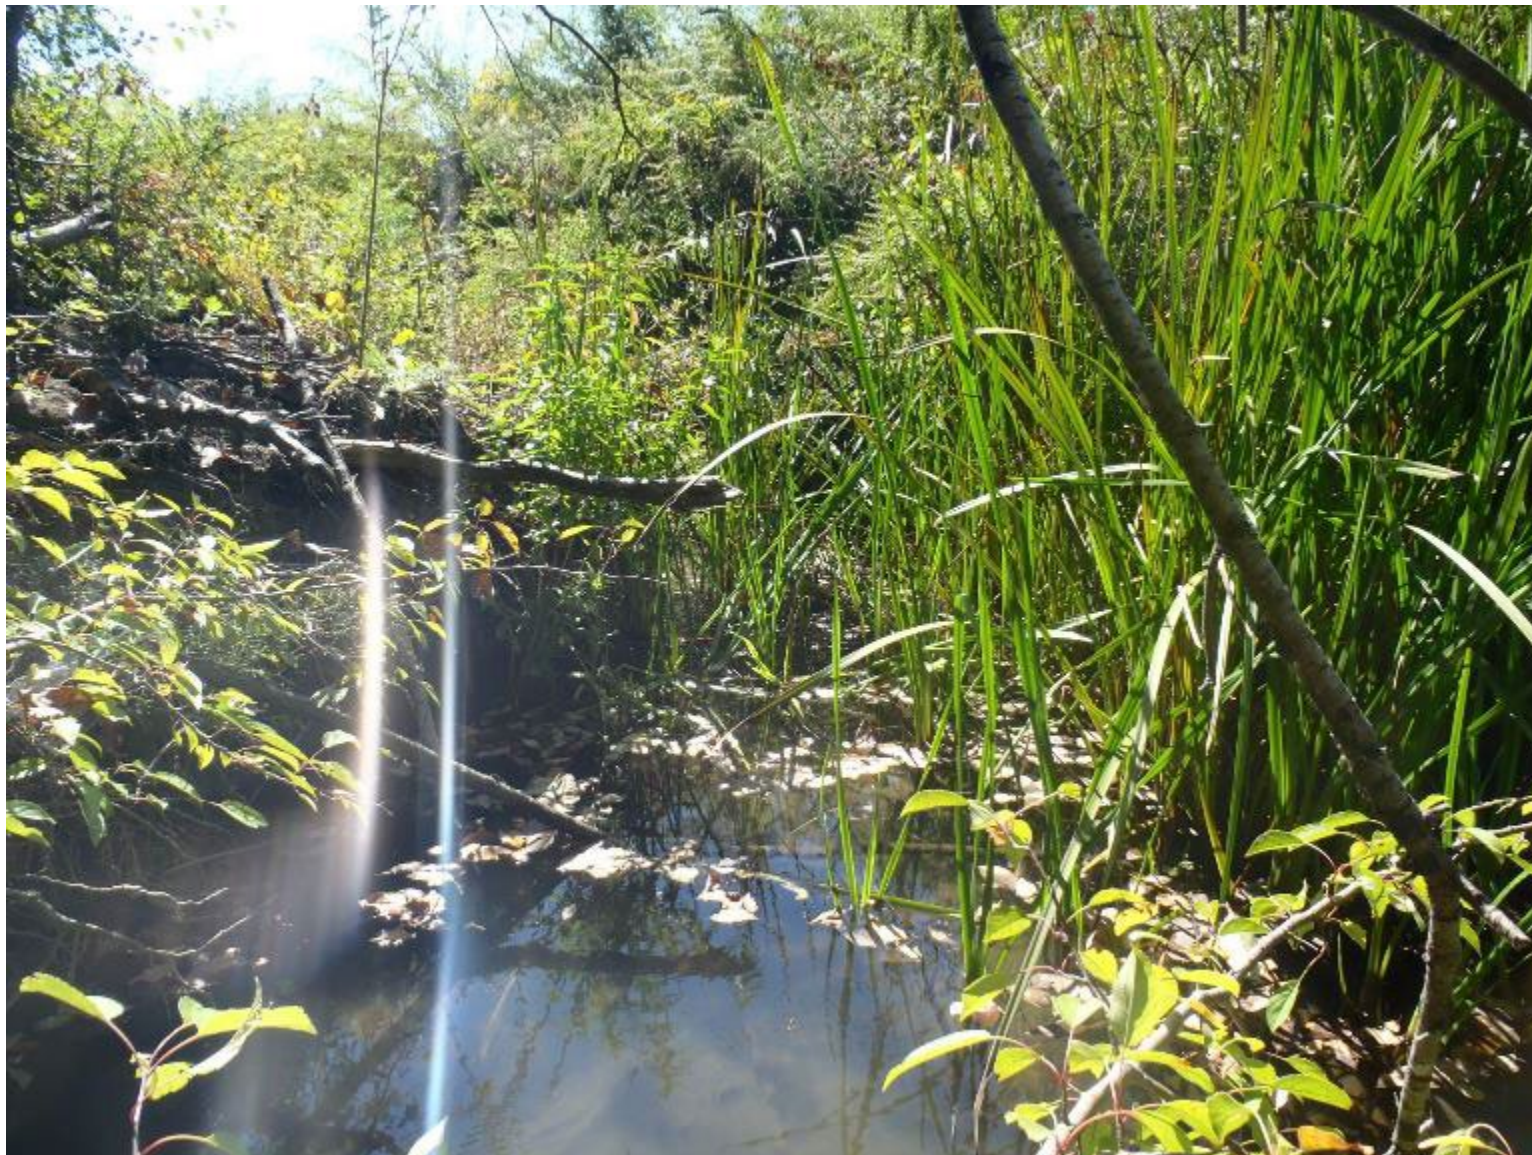
P9220008 - Upstream of Disturbance, Looking at Fill

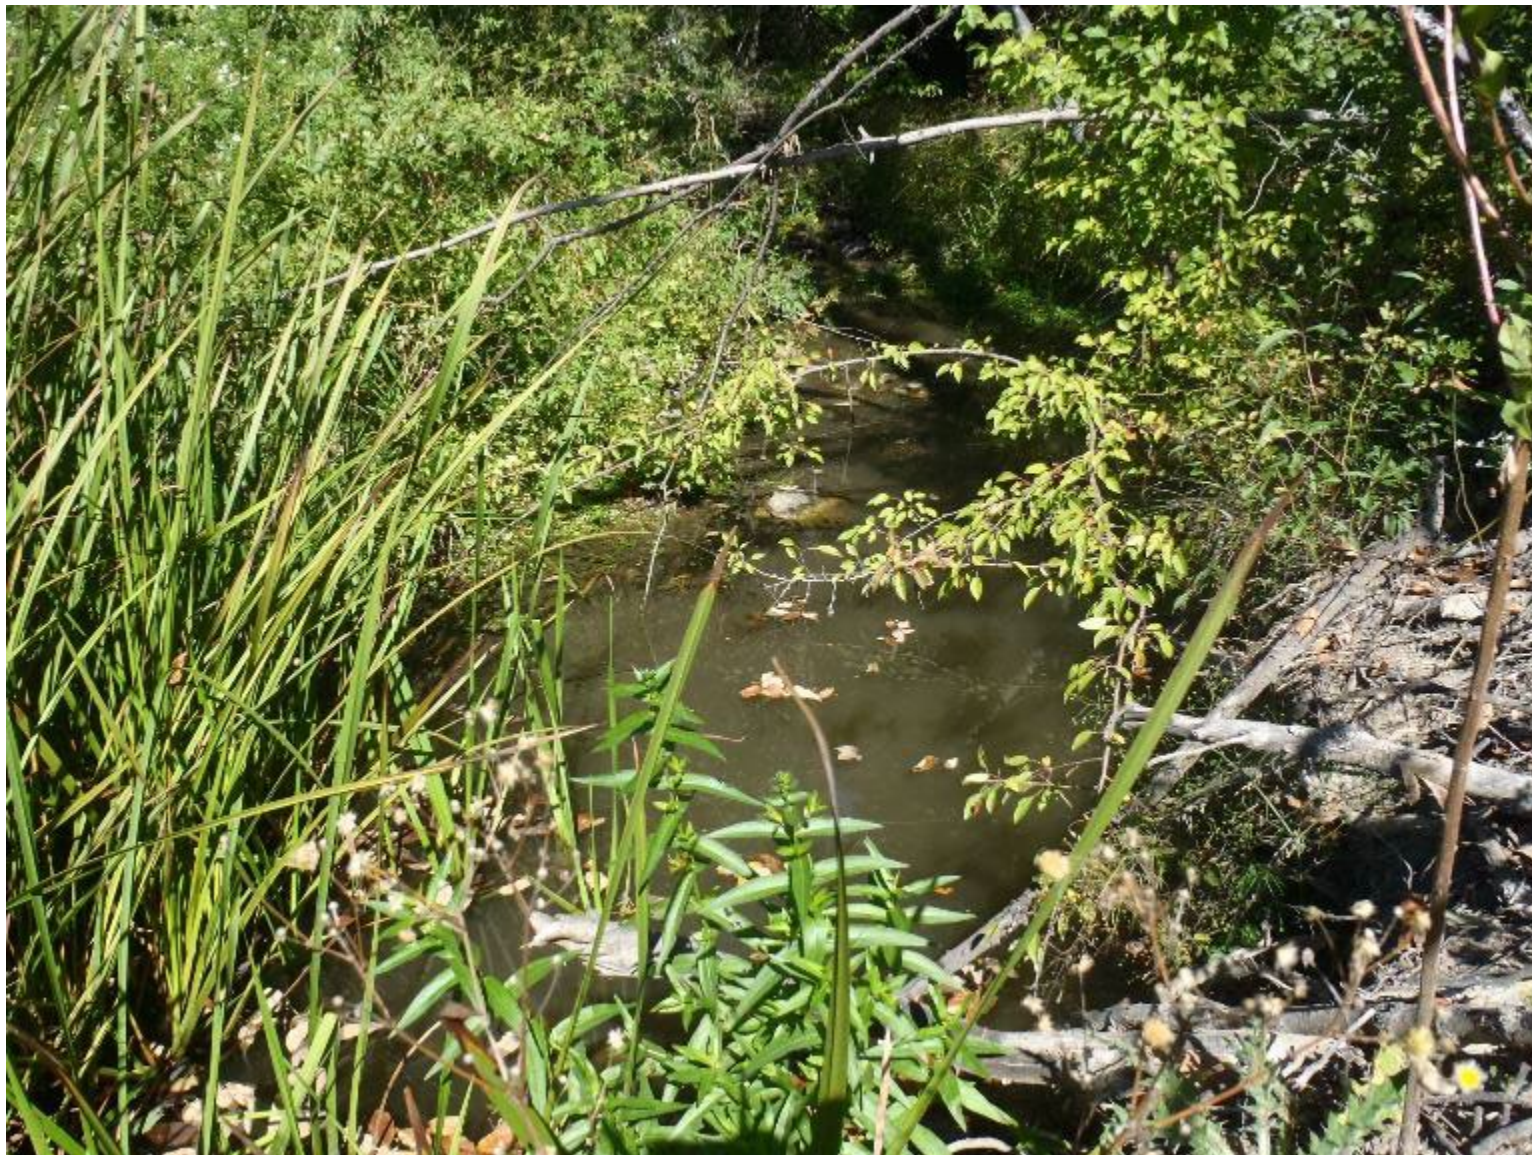
P9220009 – Taken Near Fill Looking Upstream

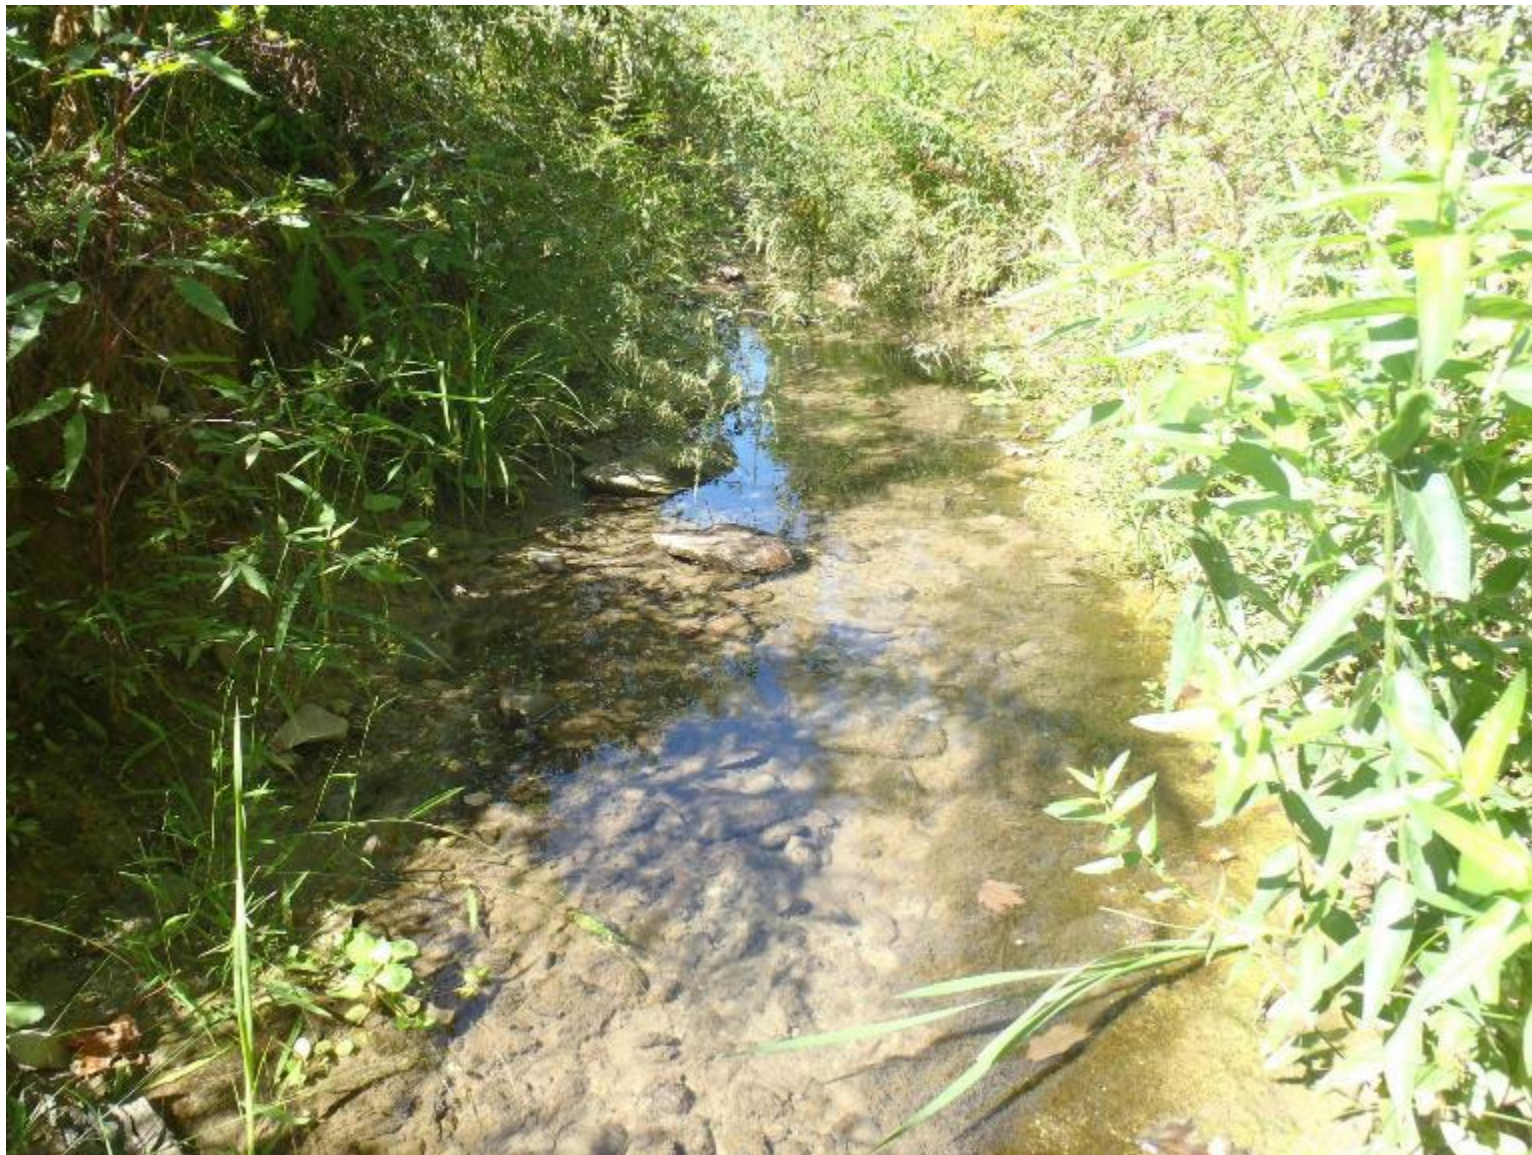
P9220010 – Relocated Stream Channel, Looking Upstream

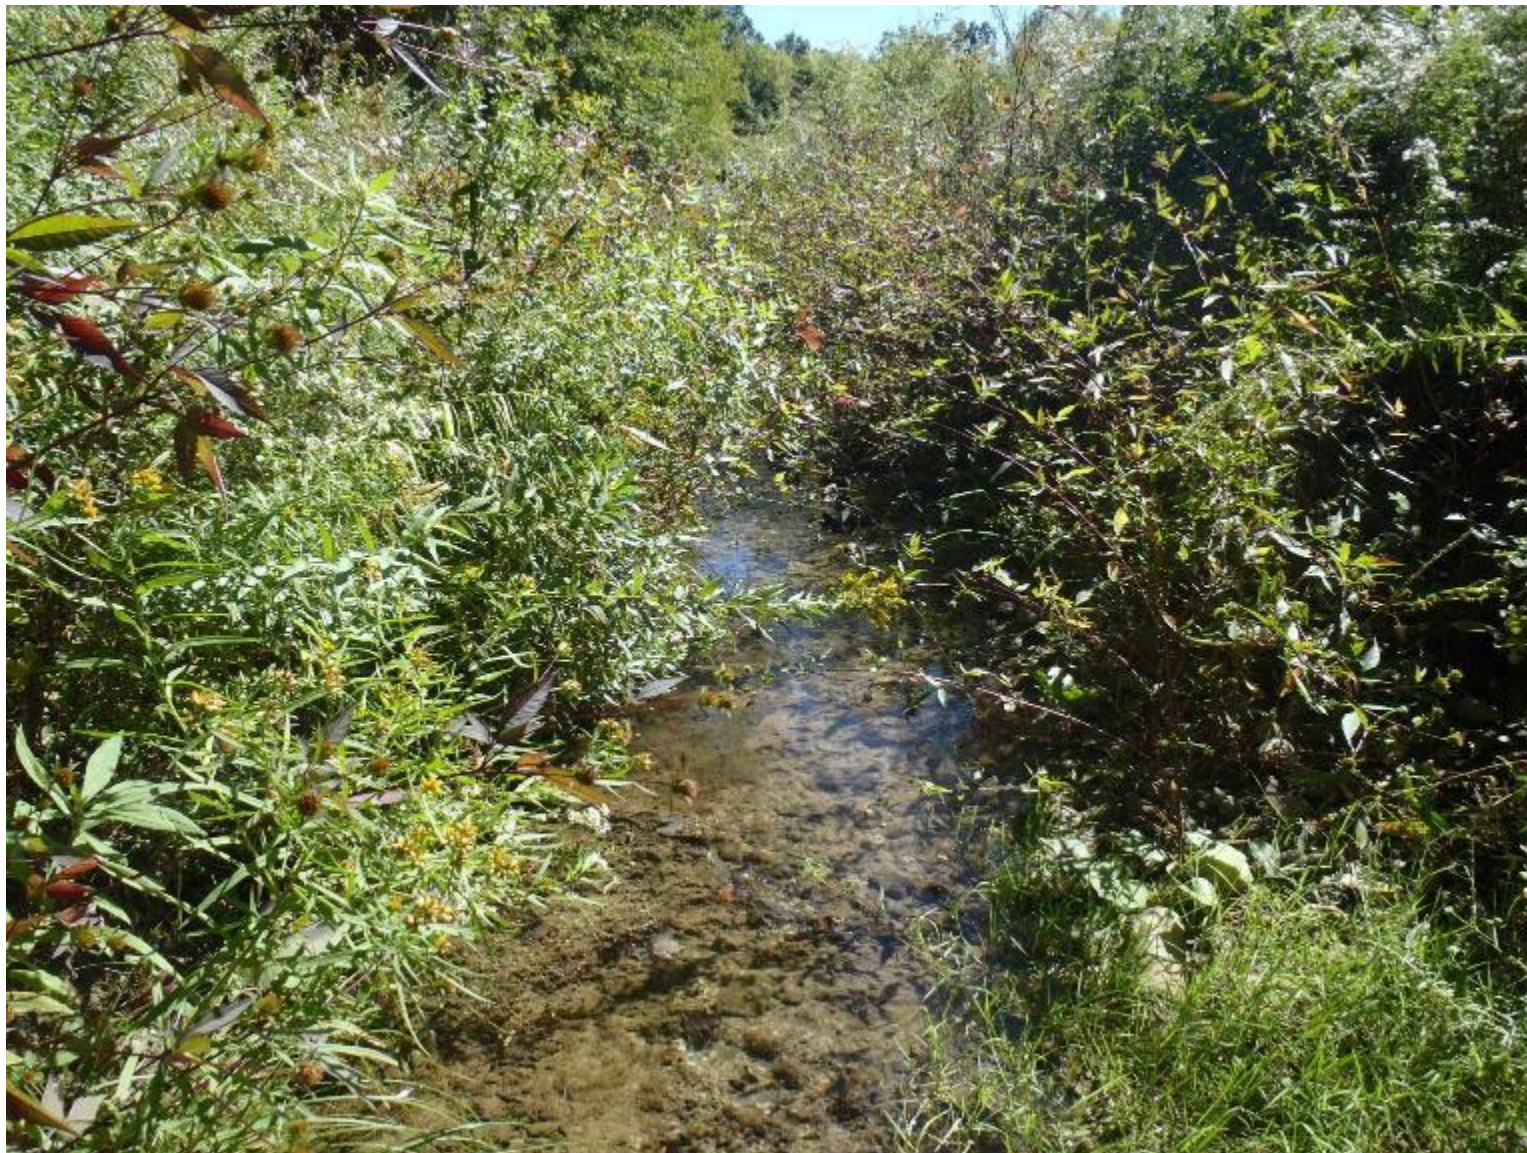
P9220011 – Relocated Channel, Looking Downstream

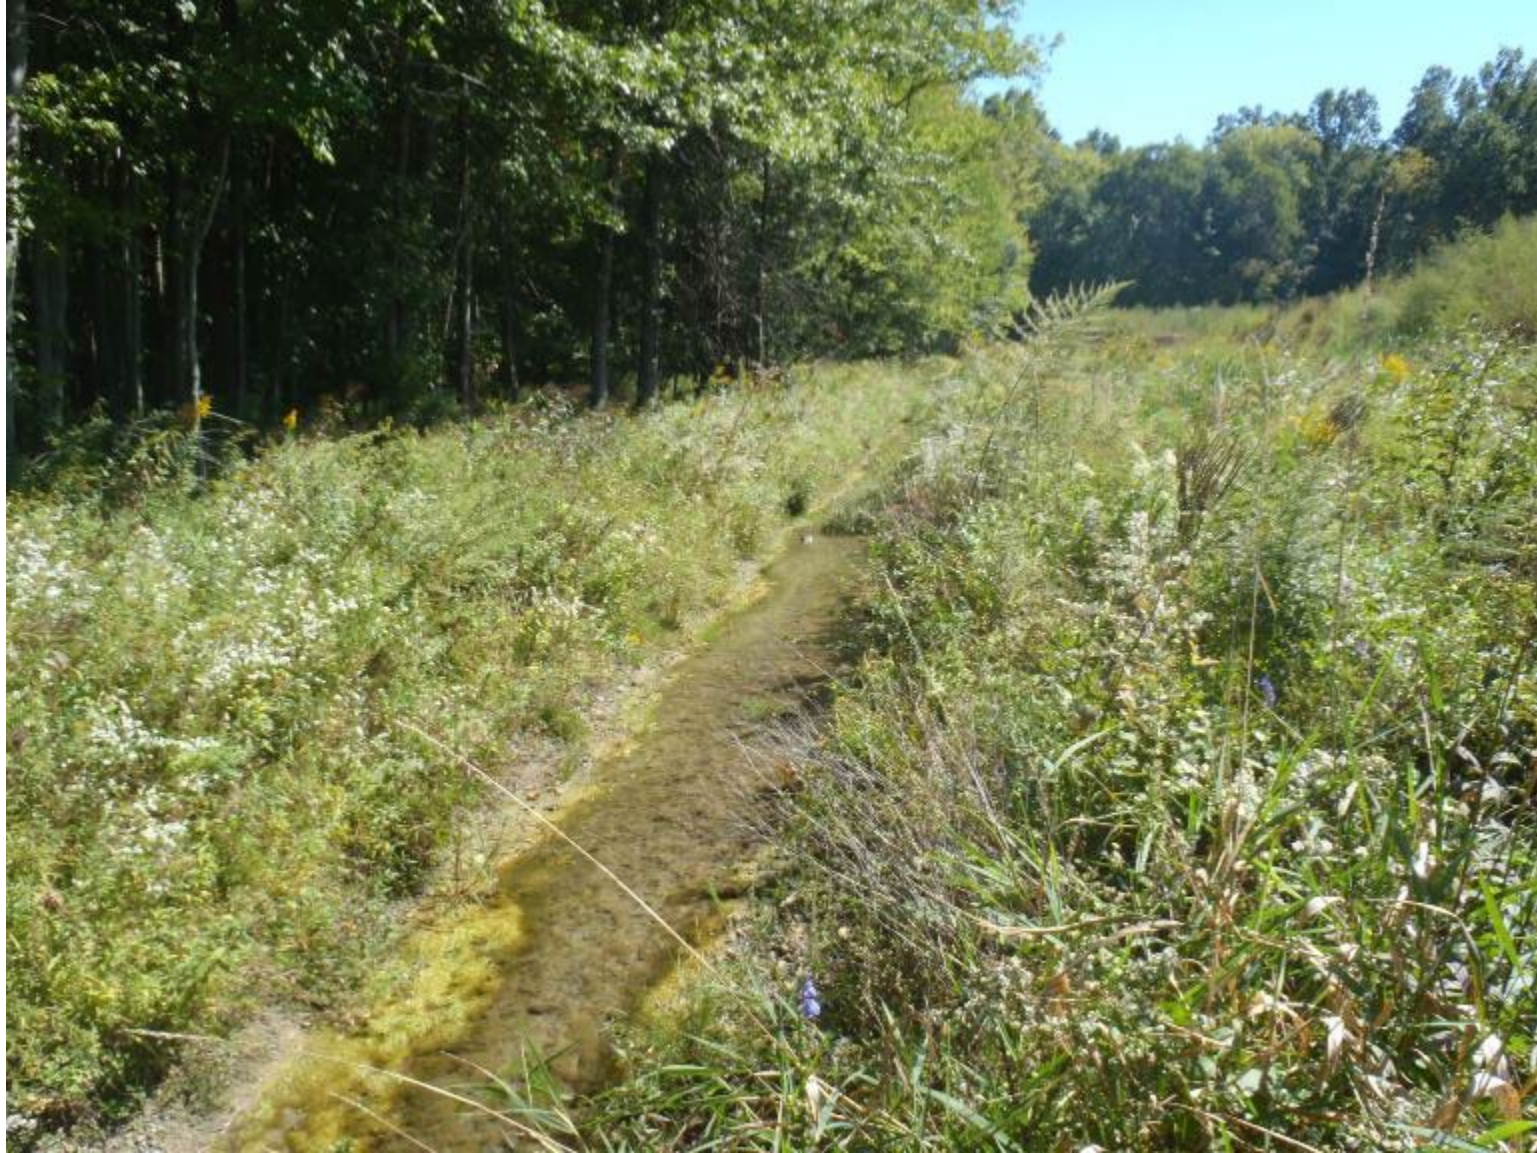
P9220012 – Relocated Channel, Looking Downstream

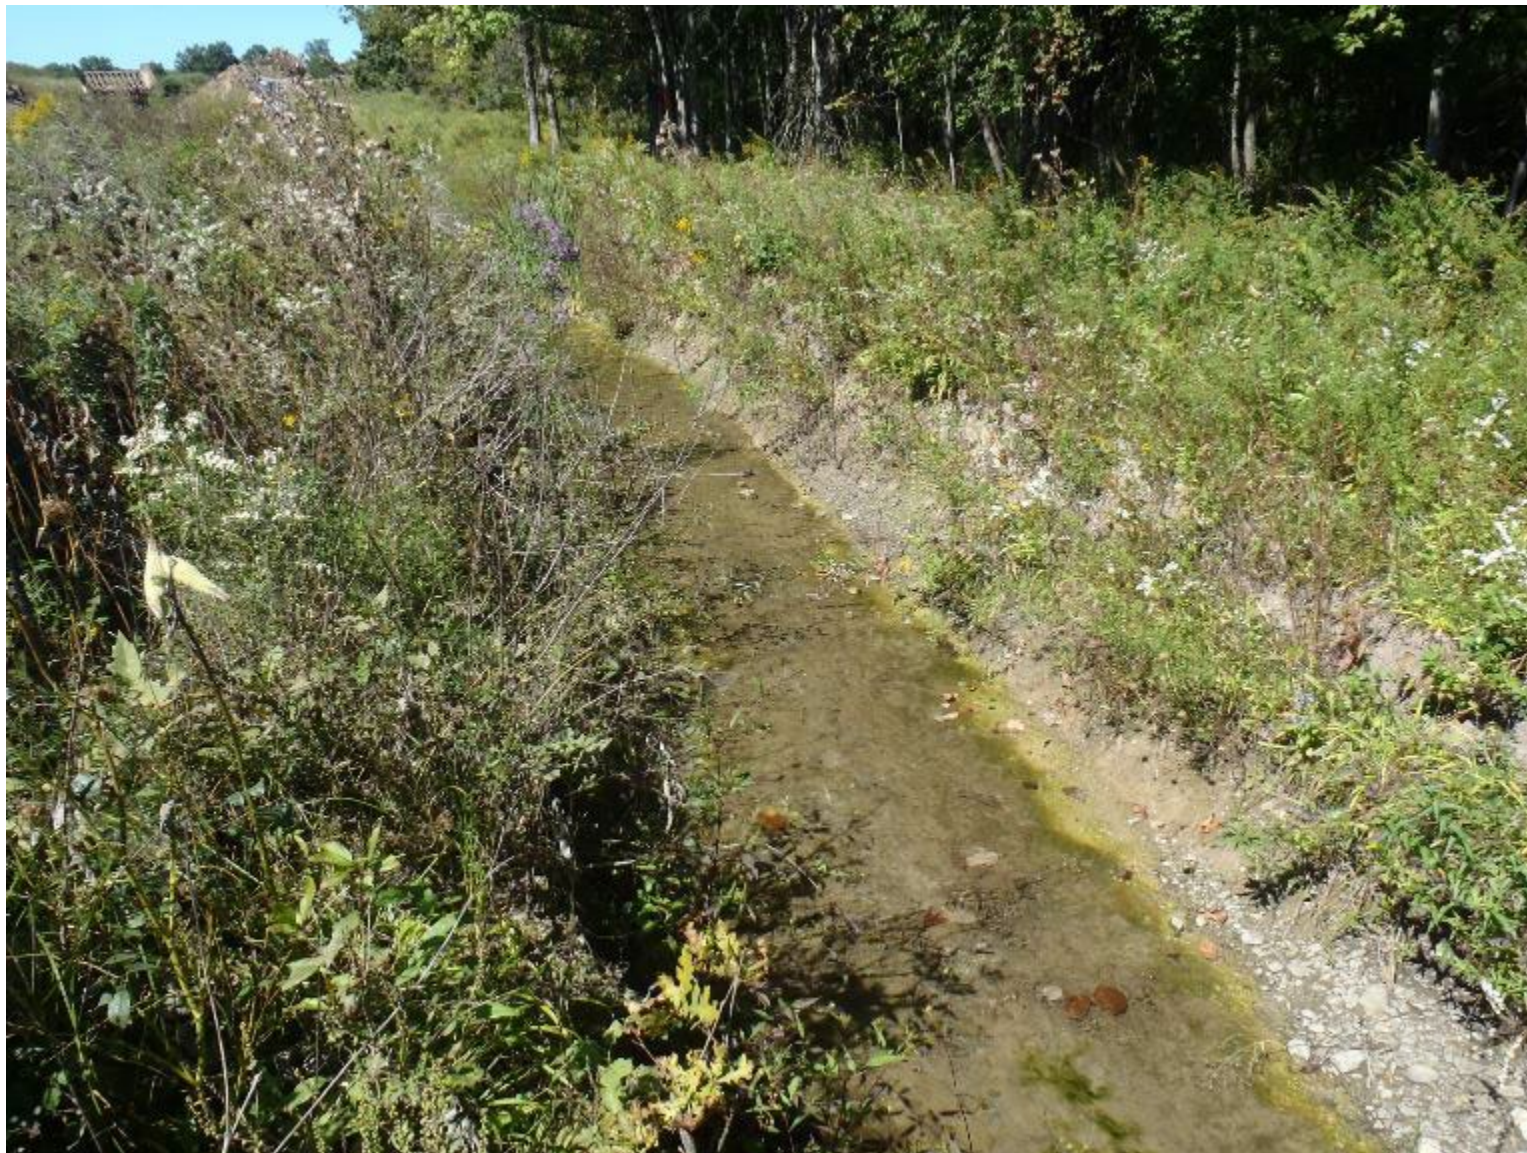
P9220013 – Relocated Channel, Looking Upstream
